TECHNICAL BULLETIN

MILITEC-1 IN A CATERPILLAR 988B LOADER

February 26, 1992

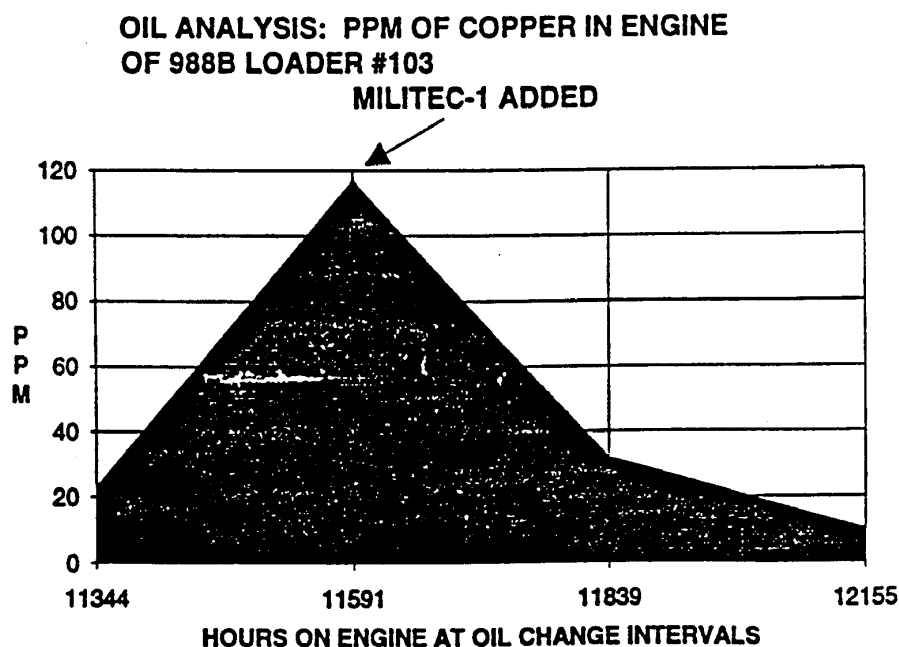
Cat #103 was treated with MILITEC-1 at 11591 hours on the engine. At this time, the oil analysis was indicating Copper levels at the extremely high level of 117 parts per million (PPM). Copper is monitored as an indicator of abnormal wear of engine thrust washers, bushings, and bearings. This provides an excellent indicator of damage occurring to the load-bearing areas of the engine. According to the head of fleet maintenance, extremely high copper levels sound the loudest alarm of all the metals monitored for wear and will result in immediate action. At this time, it was decided to treat the engine with MILITEC-1 to see if the levels could be brought down. After treatment, the engine started up noticeably easier and ran smoother.

period of 248 engine hours after which it was returned to the garage where the oil was changed and resampled. The oil analysis at 11839 hours indicated the Copper level was at 32 PPM, a drop of 85 PPM in one oil interval, but still in the high range. The drop of 85 PPM was outstanding according to the head of fleet maintenance.

The Cat was returned to operation for an additional period of 250 hours, **without any additional treatment of MILITEC-1**. Following this period, #103 was again sampled and the Copper level had fallen to 10 PPM. According to the head of fleet maintenance, this total drop of 107 PPM over two oil intervals clearly demonstrated the ability of MILITEC-1 to dramatically reduce wear in the most extreme of environments.

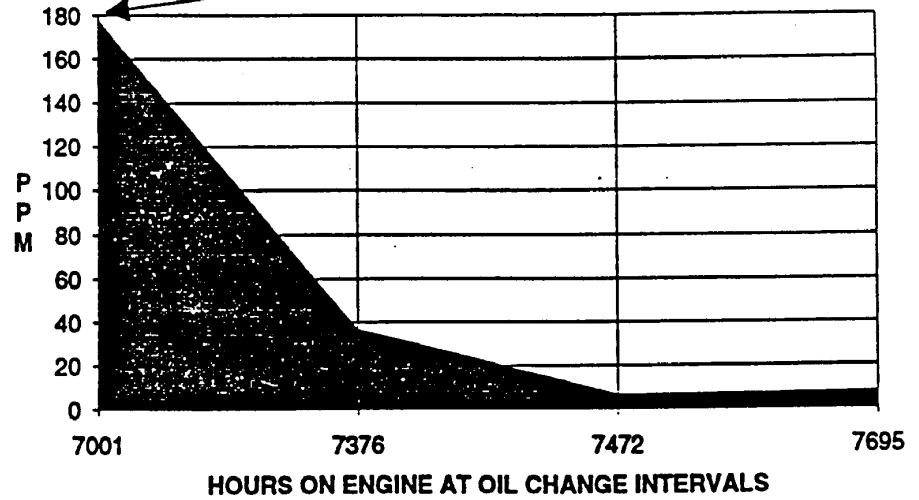
OIL ANALYSIS: PPM OF COPPER IN ENGINE OF 988B LOADER #105 MILITEC-1 ADDED

At 7001 hours on the primary engine, Cat #105 was showing a Copper level of 178 PPM, in the extremely high range. This indicated abnormal wear of the thrust washers, bushings and bearings in the engine and dictated a resampling after 250 hours to determine if extreme measures were called for including an engine overhaul. It was decided to treat the engine with MILITEC-1 at this time to see if any wear reduction could be recorded.

Following 375 hours, the engine oil was resampled. The period was longer than initially planned due to demand and another loader breaking down. At 7376 hours, the Copper levels had fallen to 37 PPM, a drop of 141 PPM in one oil change. According to the head of fleet maintenance, this was unexpected as they felt MILITEC-1 might have a chance of saving the engine, but that it would probably break down from the existing wear. The equipment was serviced and returned to the coke pits.

Following an additional 96 hours of operation, the engine was resampled. At 7424 hours, the Copper levels had fallen to 7 PPM, a total decline of 171 PPM (96%) over 469 hours of operation with MILITEC-1.

Since these results, an additional 223 hours have been put on the engine with the most recent analysis occurring at 7695 hours. The Copper level in this sample was 8 PPM, well inside the comfortable range.

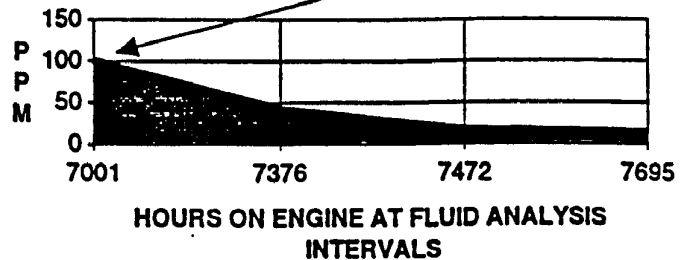
TRANSMISSION FLUID ANALYSIS: PPM OF COPPER IN ENGINE OF 988B LOADER #105 MILITEC-1 ADDED

This transmission had a history of ruining hot and had unusually high Copper levels since the day it was installed. The Copper level is monitored to gauge the wear occurring on bearings, discs, gear bushings and sleeves, all of which may sustain periods of high load.

At 7001 hours, when MILITEC-1 was added, the Copper level was 104 PPM, in the extremely high range for such a transmission. Also, the Iron level was 26 PPM, in the slightly high range. The elevated iron readings indicated wear on the shaft and gears which foretold premature transmission failure.

Following 375 hours of operation, the transmission fluid was resampled. At 7376 hours, the Copper level had fallen to 46 PPM, still in the high range but nonetheless a dramatic decline. The

Following another 96 hours of operation, the transmission fluid was again sampled. At 7424 hours, the Copper level had fallen to 22 PPM, in the slightly high range. The iron had dropped to 9 PPM, slightly below average.

After another 223 hours of operation, the transmission fluid was again sampled. At 7695 hours, the Copper level had fallen to 19 PPM, in the slightly high range but extremely low for this transmission, given its historically high levels. This was well enough in the comfort range that drastic action was no longer contemplated to save the transmission. The Iron level had remained at 9 PPM, indicating no significant wear was occurring.

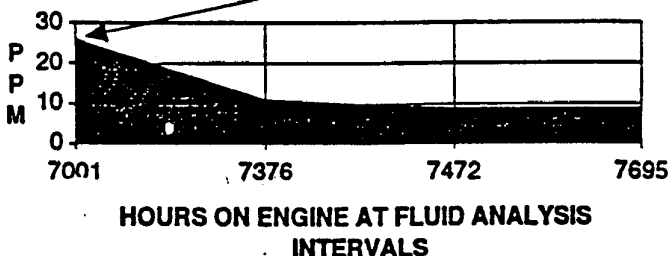
TRANSMISSION FLUID ANALYSIS: PPM OF IRON IN ENGINE OF 988B LOADER #105 MILITEC-1 ADDED

Iron level had dropped to 11 PPM which was in the average range.
